## **Solution for Continuous Caster DC Motor / Encoder Failures**

Fernando Ardines<sup>1</sup>, Bernardo Sainz<sup>2</sup>, Hector Ortiz<sup>3</sup>

<sup>1</sup>EVRAZ Rocky Mountain Steel  
1612 East Abriendo Av. Pueblo, Colorado, United States, 81004  
Phone: +1-719-561-6000  
Email: fernando.ardines@evrazna.com

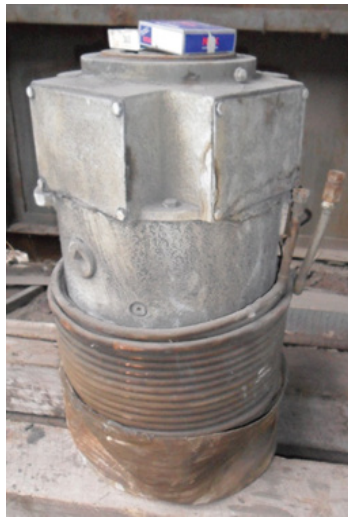
The stands often had to be removed from operation for predictive maintenance or due to failures during production, impacting overall caster productivity, yield goals and scheduling challenges. The most common motor and encoder failures were due to electrical heat fatigue. Damage to winding insulation and encoder circuits was typically attributed to high temperature exposure. With surrounding structures reported to be at 300°F during the summer, the provision of process cooling water around the motors and encoders was typically not sufficient to prevent the damage. Figure (2) shows an original DC motor with a water-cooling coil.

Figure (2). Original DC Motor with water-cooled coil in the center.

As figure (2) shows, the water-cooled coil surrounds a small portion of the motor. This can extract a portion of heat from the motor; nevertheless, it does not prevent radiant heat from reaching the motor. In addition, the DC motor heat is not easily dissipated by the exterior cooling coil since the main current flows through the rotating armature, while the stationary part only contains the field winding.

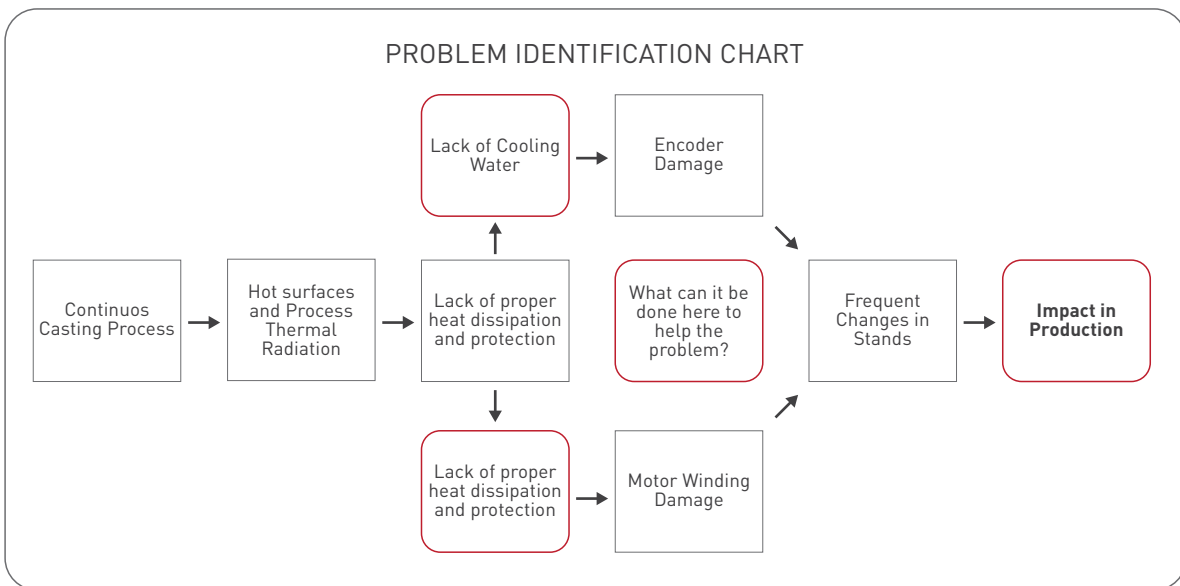
The main driver is to achieve caster operation without disruptions from motor/encoder failures. In Figure (3) is a diagram with the problem map.

Figure (3). Relational diagram for problem identification.

As the problem map in Figure (3) shows, the following problems were defined:

- Excessive heating of the main motor/encoder unit.
- Excessive heat of main motor assembly structure.
- Encoder dependency for the process.
- Change of stands wiring methods.
- Dependency of cooling water.

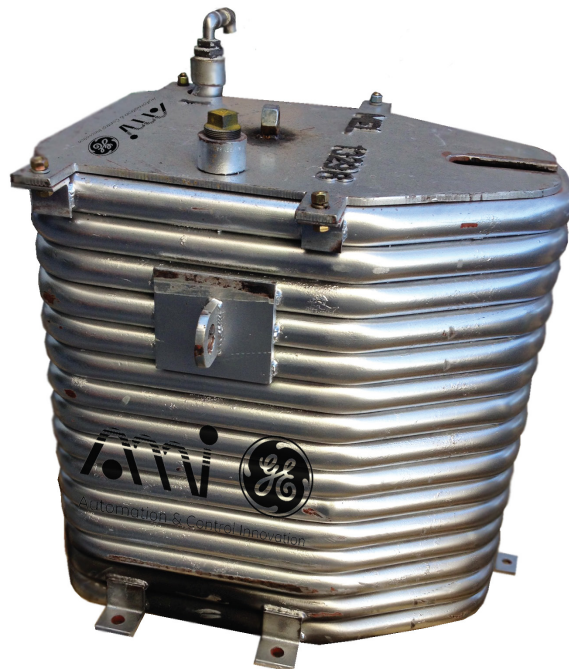
The strong negative relationship is supported by TRIZ principles of design. To prevent overheating generated by the cast blooms from reaching the motor assembly, a shield was installed shown in Figure (6). The shield is constructed by an upward coil made of tube, which circulates water in an upwards direction from the process cooling water.

- ▶ Blocks the heat transfer from the blooms from reaching the motor and encoder.
- ▶ Removes the incidental bloom heat by means of the circulating water.
- ▶ Exposes a cooler face to the interior of the shield.
- ▶ Prevents dust and particles from free falling into the encoder.

Figure (6). Motor heat shield assembly.

As shown in Figure (4), heat to the motor was primarily from two sources: 1) bloom radiation heat and 2) stand structure heat by conduction. To reduce heating from the stand structure, a cooling base was attached. Now rather than mounting the motor directly to the stand, the motor is mounted onto the cooling base. The base is cooled by process water in the same circuit as the upper coil. Hence the motor shield comprises: a cooling base, an upper wall water coil and a cover plate (without water flow).
